Mine Name	Mine ID	Operator	Activity Type	Region	Activity Date
Grosvenor Coal Mine	M102976	Anglo Coal (Grosvenor Management) Pty Ltd	Inspection	Central	05/07/2016

## Mine Record Entry

### 1.0 Roof Fall HPI Report 101 LW- 2422m chainage

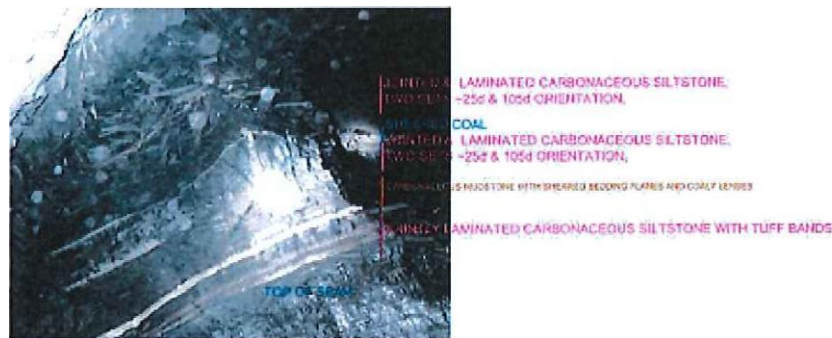
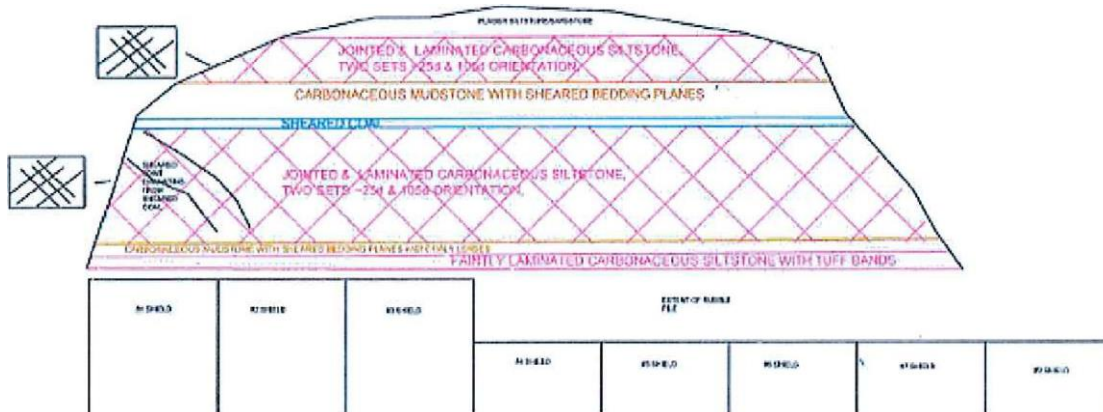
In regard to the fall at 101 MG Mr Bull explained that he had inspected the face on the previous day. A cavity at 3-4 support was beginning to lip on and bagging of the mesh just outbye the face-end was observed but not considered significant. Rock props had been set on the travel side of the BSL but overall conditions looked to be improving.

Wayne Bull (UMM) reports cavity at chocks #3 and #4 beginning “to lip on” and bagging of mesh just out-by the face line at the maingate. Assume “lip on” is manager speak for cavity getting bigger

Later, on the sixth shear for the day, as the shearer entered and pulled up the face from the MG a fall occurred —a photograph of a view into the cavity and a cross section of the strata are shown above.

The conditions at the maingate were effectively communicated shift to shift and the fall was unexpected. Later, on inspection, the nature of the roof was highly laminated with a highly polished layer close to the top of the cavity. The cavity was largely empty of debris as it had slid out into the hole in front of 1-2 support.

Dayshift crews were involved during the inspection consolidating the approach to the fall by pinning extra heavy duty mesh along the BSL to the fall and propping the travel side of the BSL. They were also conducting a risk assessment to establish a recovery plan for the immediate fall area. The details are still to be established but they will include cavity filling on face and in the gate, reinforcement of the coal face and in advance in the gate and, spiling from the gate in advance of the face.

The current status of the conveyor road support outbye of the immediate fall will need to be assessed with suitable reinforcement provided the timing of which is critical. Mr Bull is to provide a copy of the full recovery plan once it has been established.

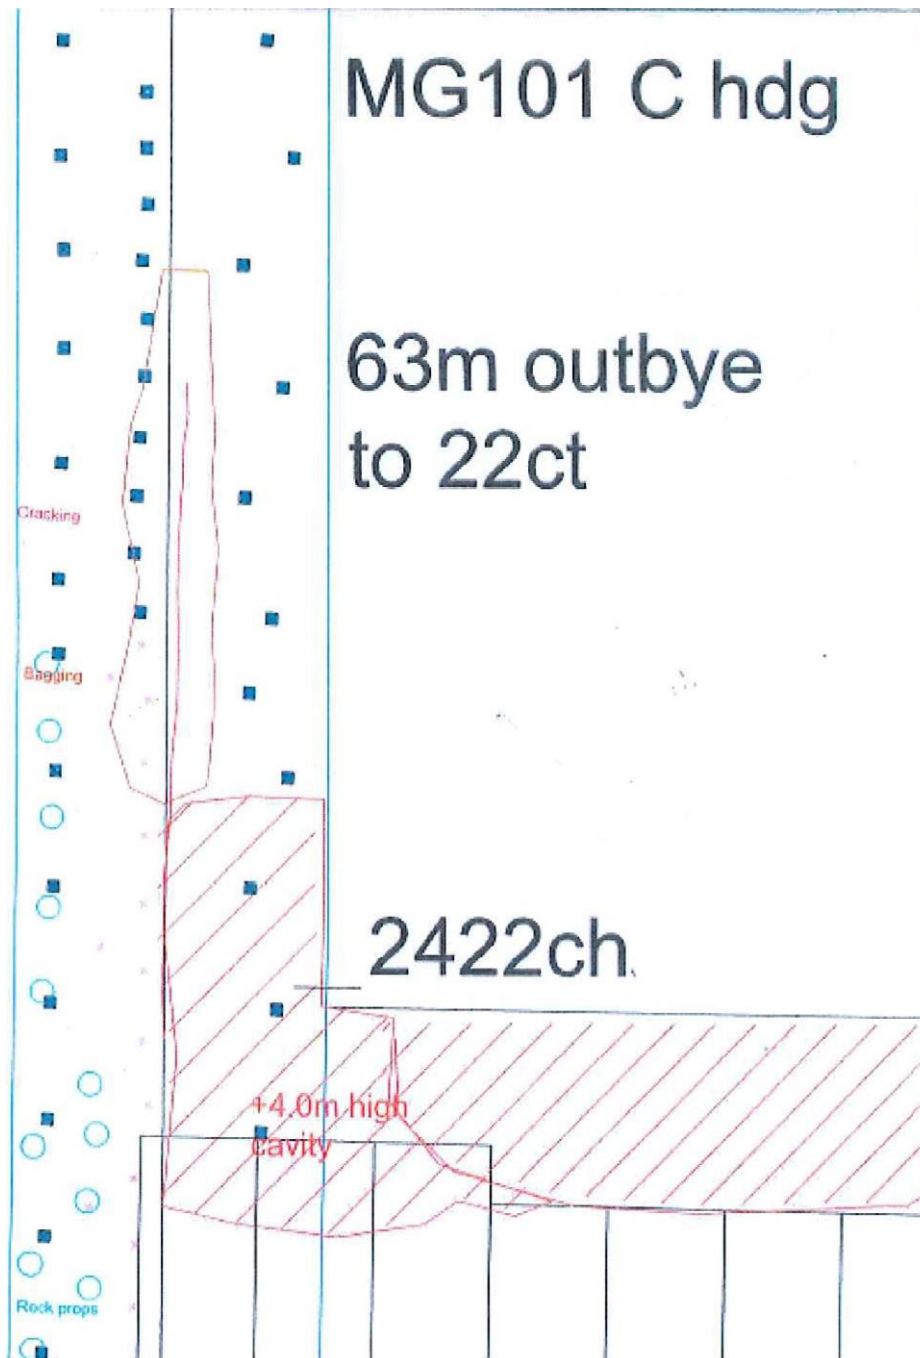
### Location of Megabolts and Rock Props

- Developed horizon in the MG means that the floor cutting horizon is lifted thinning the coal roof on the normal run of face. There is a need to grade up into the maingate end of the face.
  - The face is in 'Domain A' where there is a seam split of the top ply.
  - The mining depth is 350m.
  - In development, roof support provided between intersections was 8x 1.8m JX bolts plus two 8.2m megabолts each 4m.
  - Secondary support was added between intersections and the following diagram shows positions of all megabолts, and temporary rock props at the MG face end.
- e There was a small amount of floor lift and roof cracking along the BSL.
- The full support provided will be analysed as part of the Mine investigation.

█ A discussion later the following day with Mr Bull suggests that an option will be to introduce a centrally placed 8.2m megabолt before the belt extension in the development stage to better even out the support provided.
