Mine Name	Mine ID	Operator	Activity Type	Region	Activity Date
Grosvenor Coal Mine	M102976	Anglo Coal (Grosvenor Management) Pty Ltd	inspection	Central	22/08/2016

## Mine Record Entry

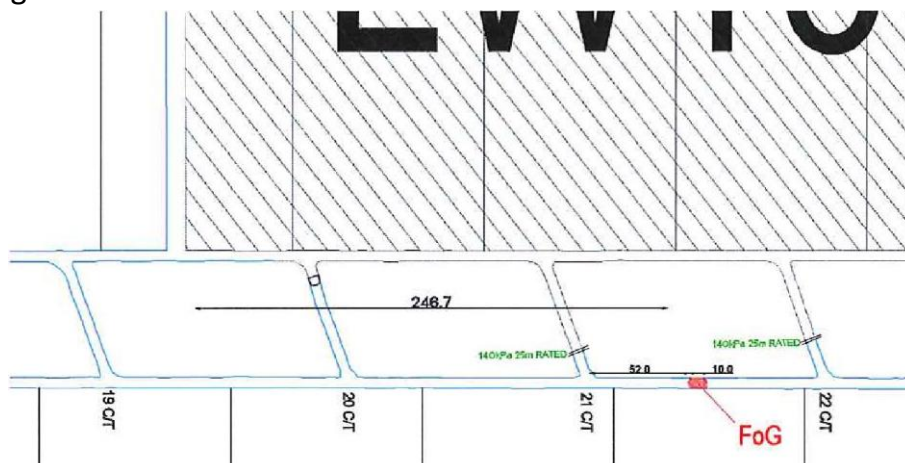
Figure 1 - Location Plan

'A fall of ground occurred between the hours of 0530 and 0730 on the 20th August 2016 in Grosvenor Mine MGIOI B Heading, approximately 42m inbye of 21C,m intersection (Figure 1).

The position of the longwal/ (LWIOI) is approximately 250m outbye of the fall of ground At the time of the fall} MG CH2034 and TG CH2037.5.

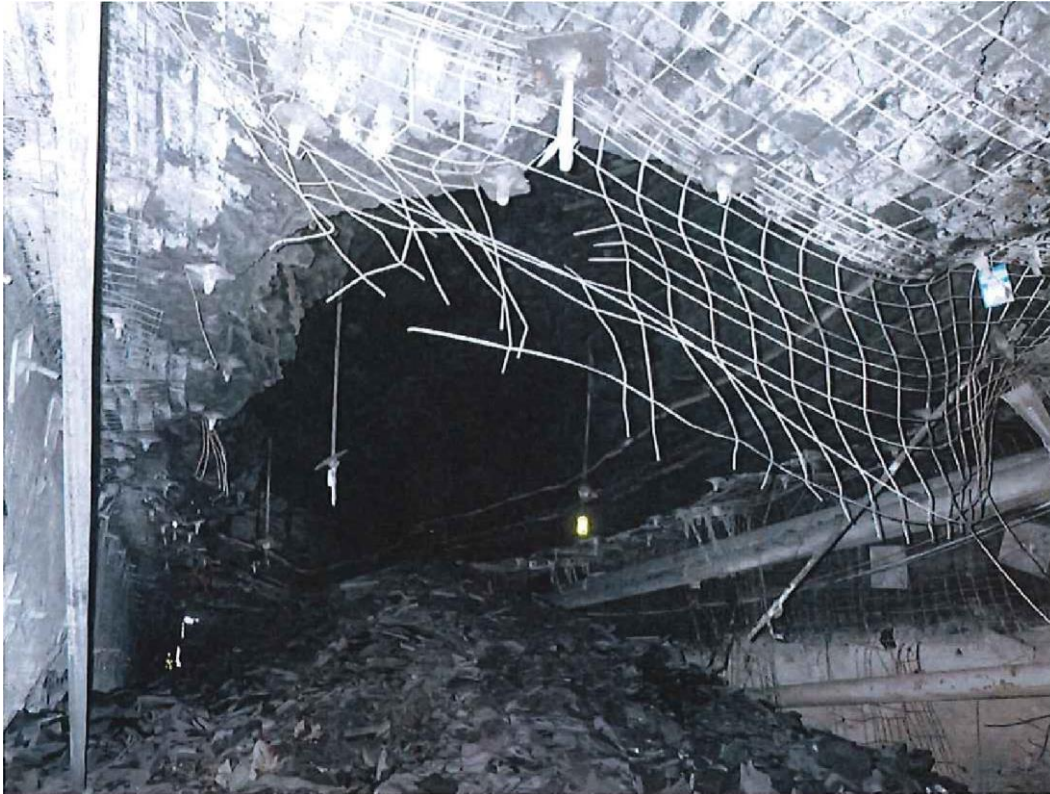
The FOG was identified by the UM (R Whatman) and Geotechnical Engineer (A Seccombe) at 0700 on the 20th August 2016. Area was being inspected due to NS reports of roof bagging and movement The fall area was already No-Roaded by night shift ERZC "

**Where are the tell tales every 15m from previous falls?**

**Fall found by Whatman (Shift Supervisor) and A Seccombe (Geotechnical Engineer)**

The roadway outbye the fall had been re-supported to the lip and shotcreting commenced as part of the recovery. The window of time presented before the shotcrete hardened sufficiently, allowed the longwall to advance and be secured to deal with broken roof conditions

The longwall stand-down will allow the necessary remedial support to be installed in and around the roadways surrounding the longwall and far enough in advance of the longwall to, as far as possible, avoid more roof failures. The senior management team had assembled to identify the scope of the remedial work the deemed necessary.
