CENTRAL COLLIERY

**312 GERMAN CREEK LOWER
CH₄ "FLOOR BLOWER" REVIEW**

Darren Pisters
Chief Geologist
September 2004

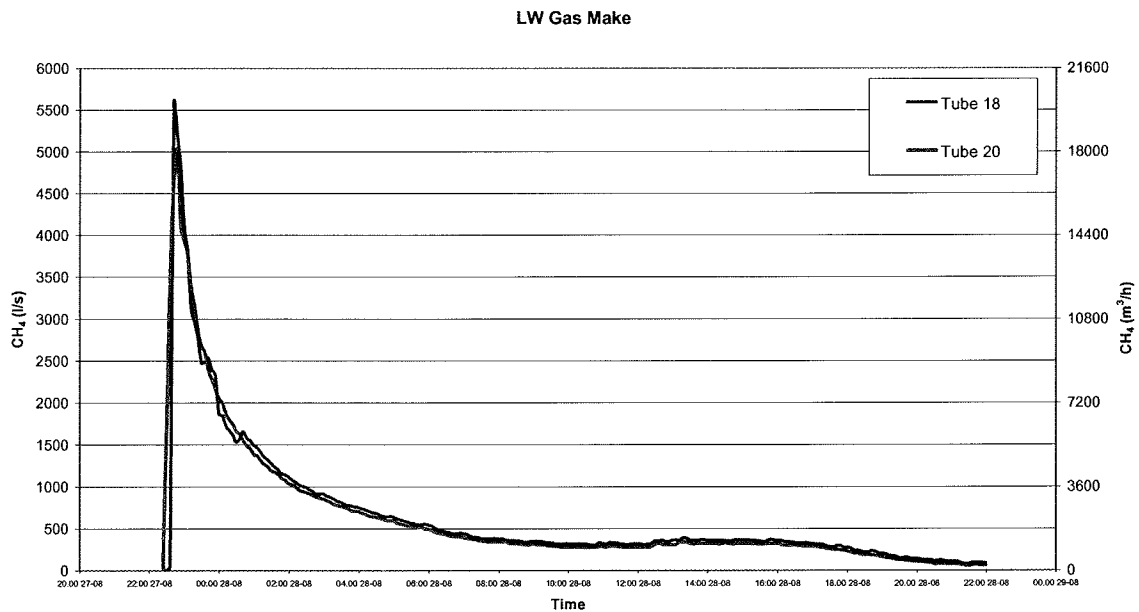
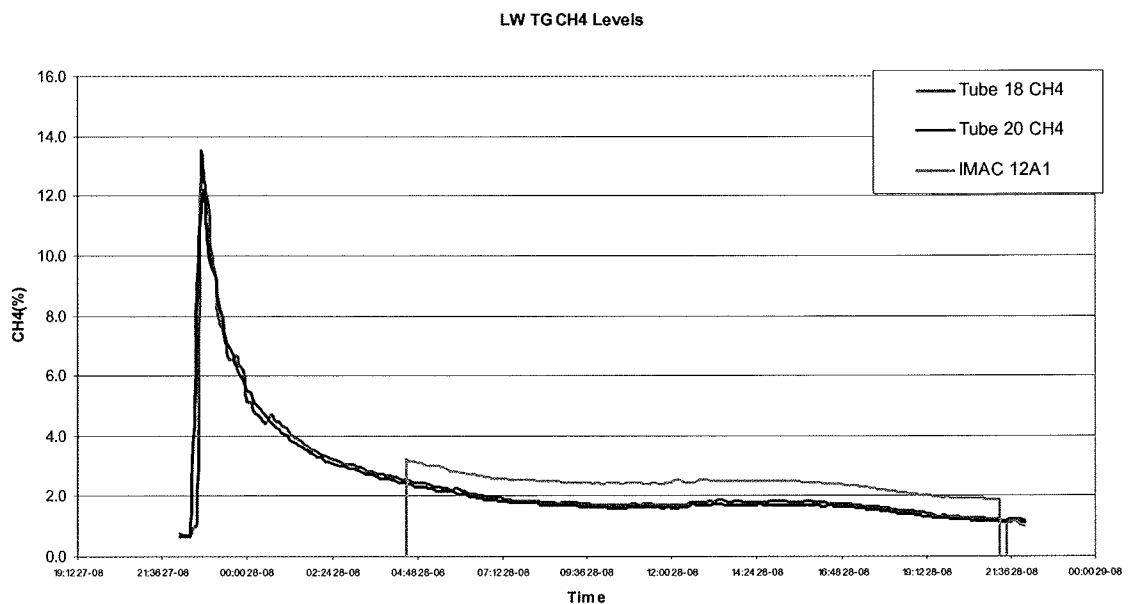
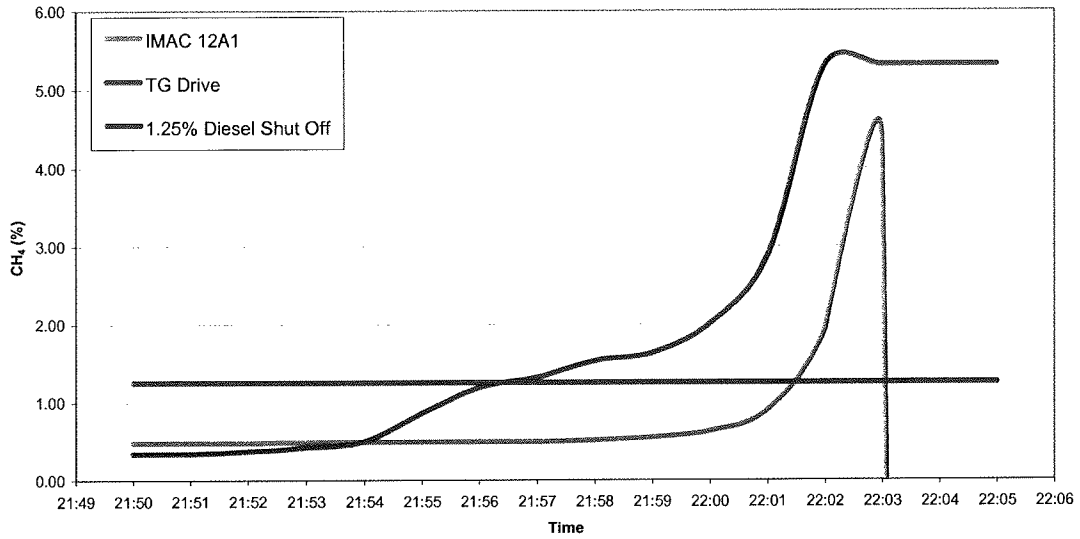
At approximately 10 PM Friday 27 August 2004 an inrush of methane from the floor along the longwall face affected the longwall return sufficiently to cause an evacuation of the mine as per Longwall Floor Gas PHMP TARP. Peak readings of 13.4% methane at over 5500 litres per second were recorded. A Total of 43,471 m³ CH₄ was recorded from the mines gas monitoring systems. The wall was not in production and the event closely followed a weighting event on the face where numerous supports were recorded to be on yield. Several floor cracks emitting methane were recorded along the face at chock numbers 24, and 68 with a major crack at chock number 80. Figures 1,2 and 3 illustrate the event.

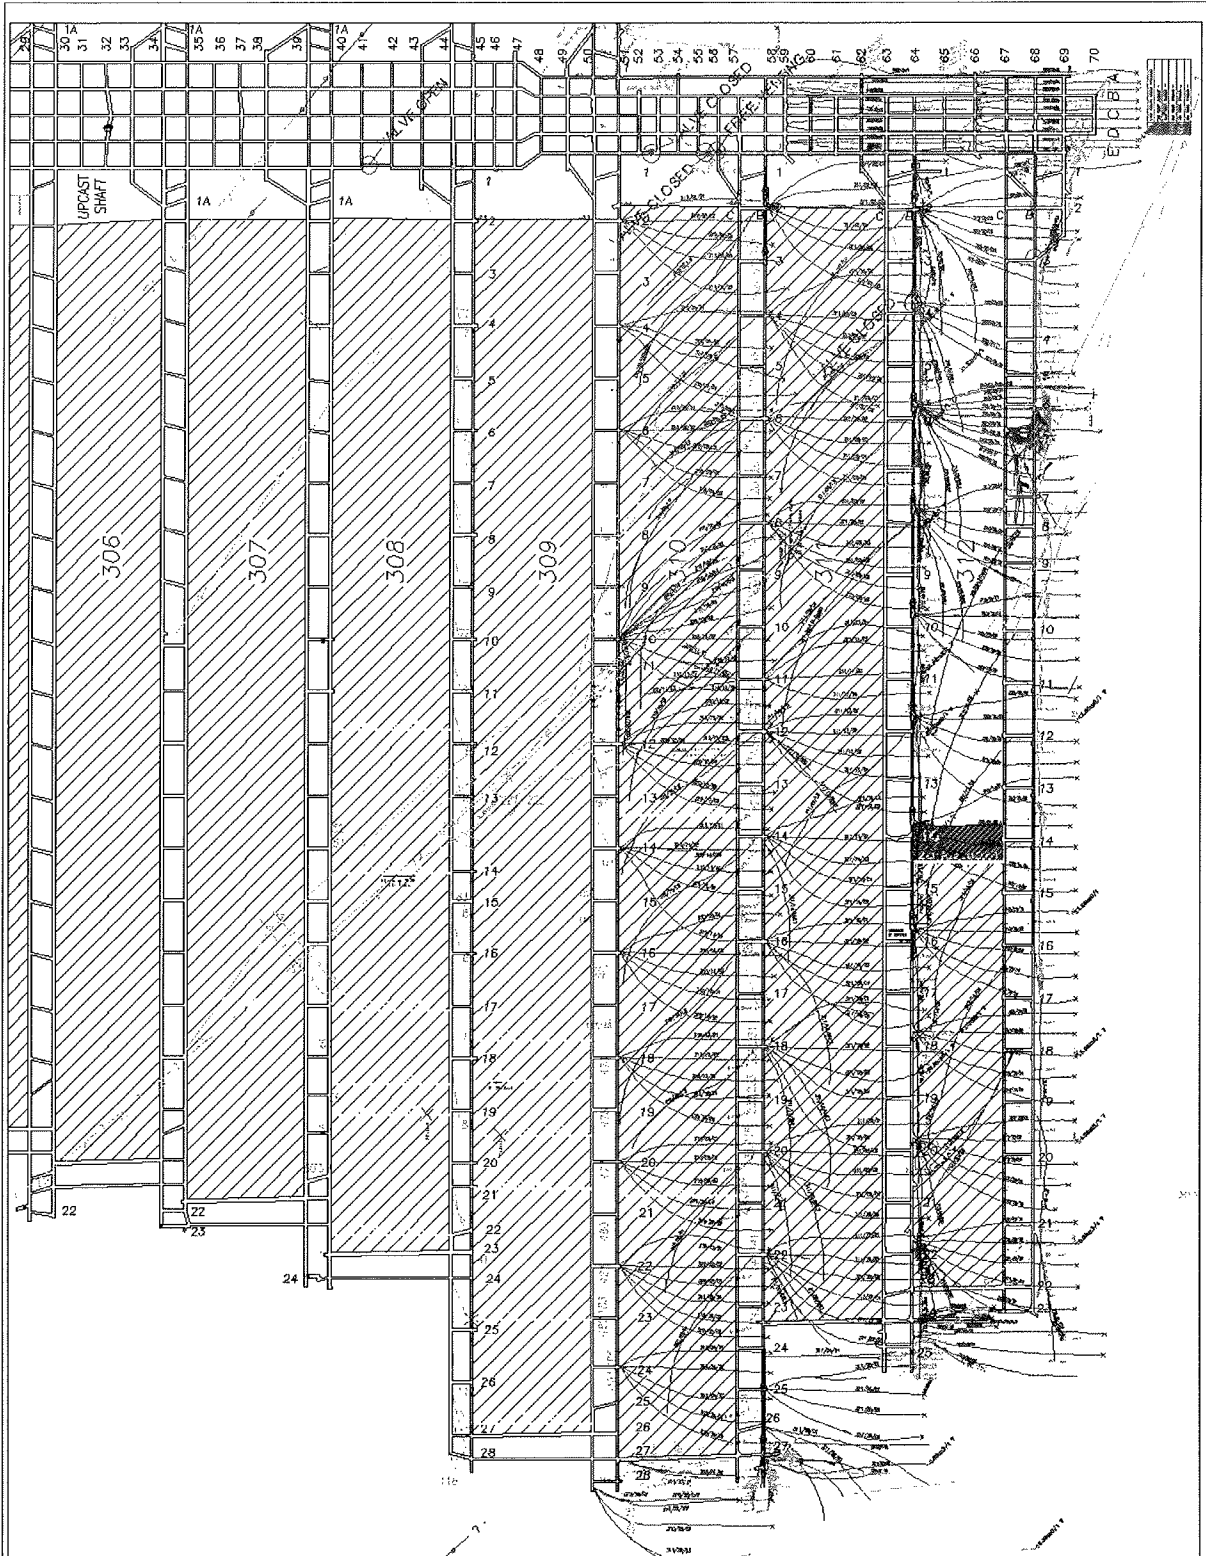
Figure 4: GCL Gas Inrush Location Plan

The gas incident at 310 LW on the 11th March 2002 can be seen from Figure 4 to be largely related to a floor hole not being drilled at this location. The second incident on the 6th June 2002 was related to the floor hole being turned off at the collar. Therefore the incident on 27th August 2004 at 312 can be considered the first “true” failure of the floor drainage system and therefore requires to be evaluated in detail. The next series of sections further evaluates this failure.

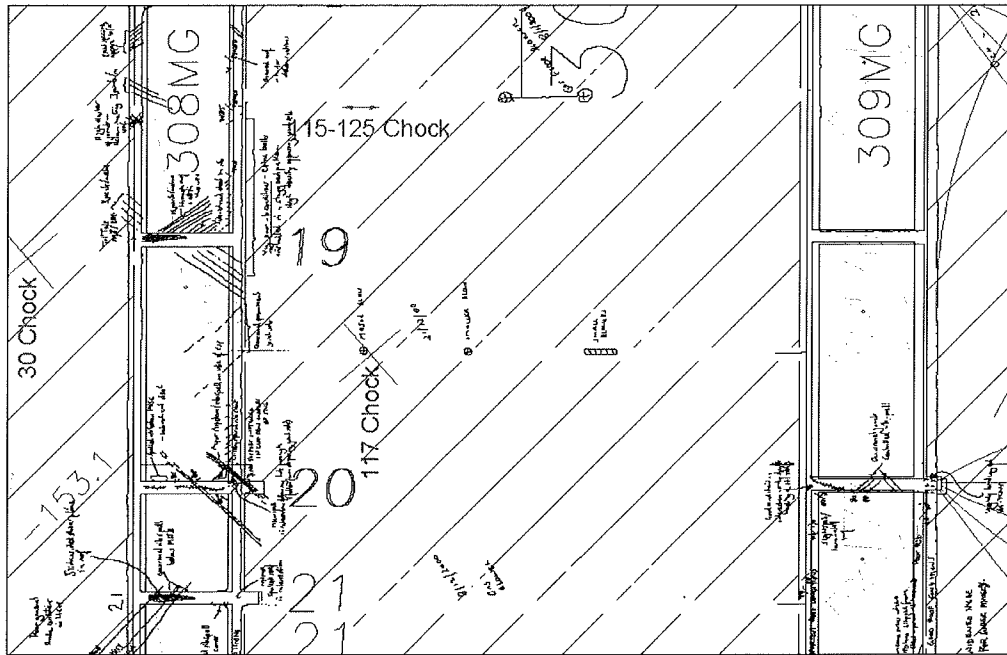
Figure 9 – 309 Gas Inrush Locations and Geological Structure

The location of the events in 309 between the 8th Dec 2000 and 9th Jan 2000 can be seen on figure 9 to be in the vicinity of high density jointing at 19 C/T and 20 C/T.

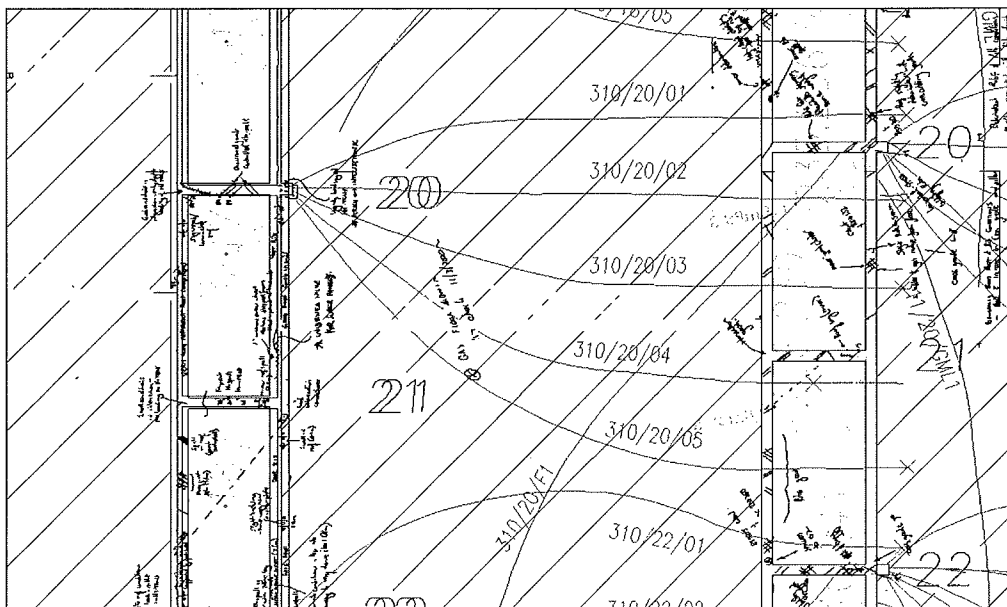
Figure 10 – 310 Gas Inrush Locations and Geological Structure.

The event in 310 on 11 March 2002 occurred in an area where a floor hole was not present in the TG area. Therefore this event can largely be related to this fact. However, the location of the main gas blower as seen on figure 10 (cross on mapping on wrong chainage) correlates with a high density cleat/joint zone between 21/22 C/T on the TG and 20 C/T on the maingate.

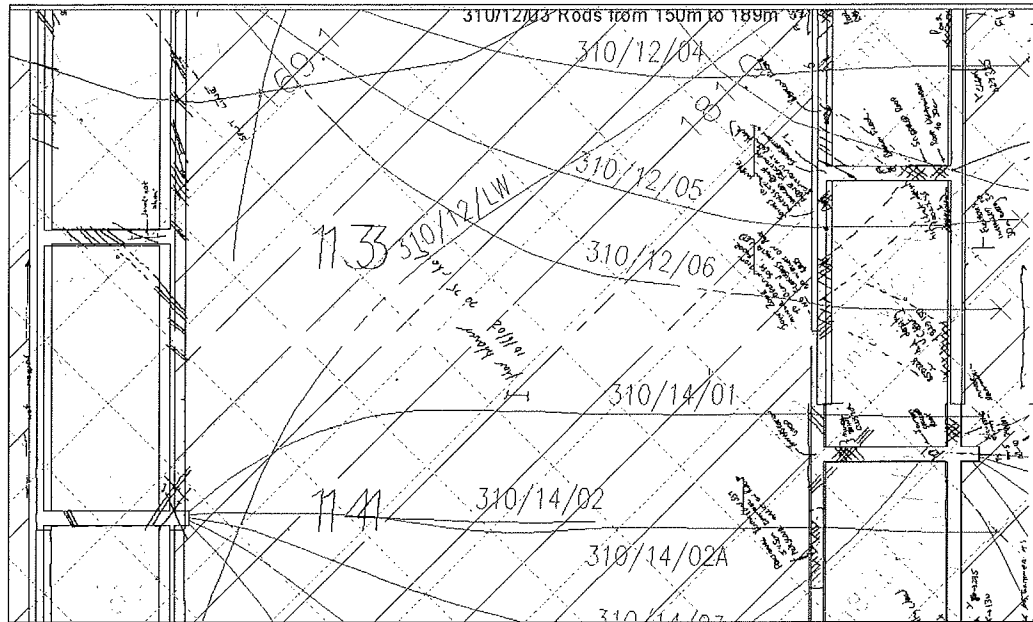
Figure 11: 310 Gas Inrush and Geological Structure

The event in 310 LW on 10 June 2002 was in a location where a floor hole had been turned off at the collar. This event can therefore not be regarded as a failure of the system. Gas make was reported to be in the mid face region which is the most likely location for cracking to occur. Figure 11 shows also that the mid face region is an area of intersecting joint sets from both the maingate and the tailgate. In this case however, it is not clear whether structure plays any role with the location of the floor blower.

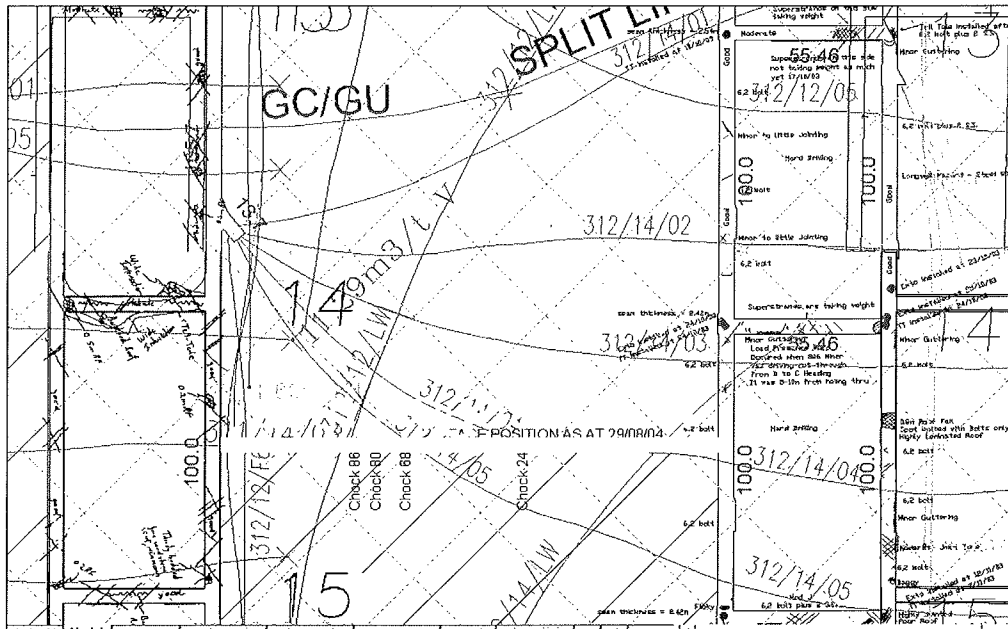
Figure 12: 312 Gas Inrush and Geological Structure

The event in 312 LW on the 27th August 2004 occurred in a location where conditions on the maingate were recorded as good with very few joint sets. Conditions on the tailgate were similar with minor joint sets around 15 cut through. This is interesting, as benign conditions may have reduced the ability for cracking beneath in the goaf under normal weighting conditions and allowed for an accumulation of methane to occur without release to the interburden hole or to the goaf.

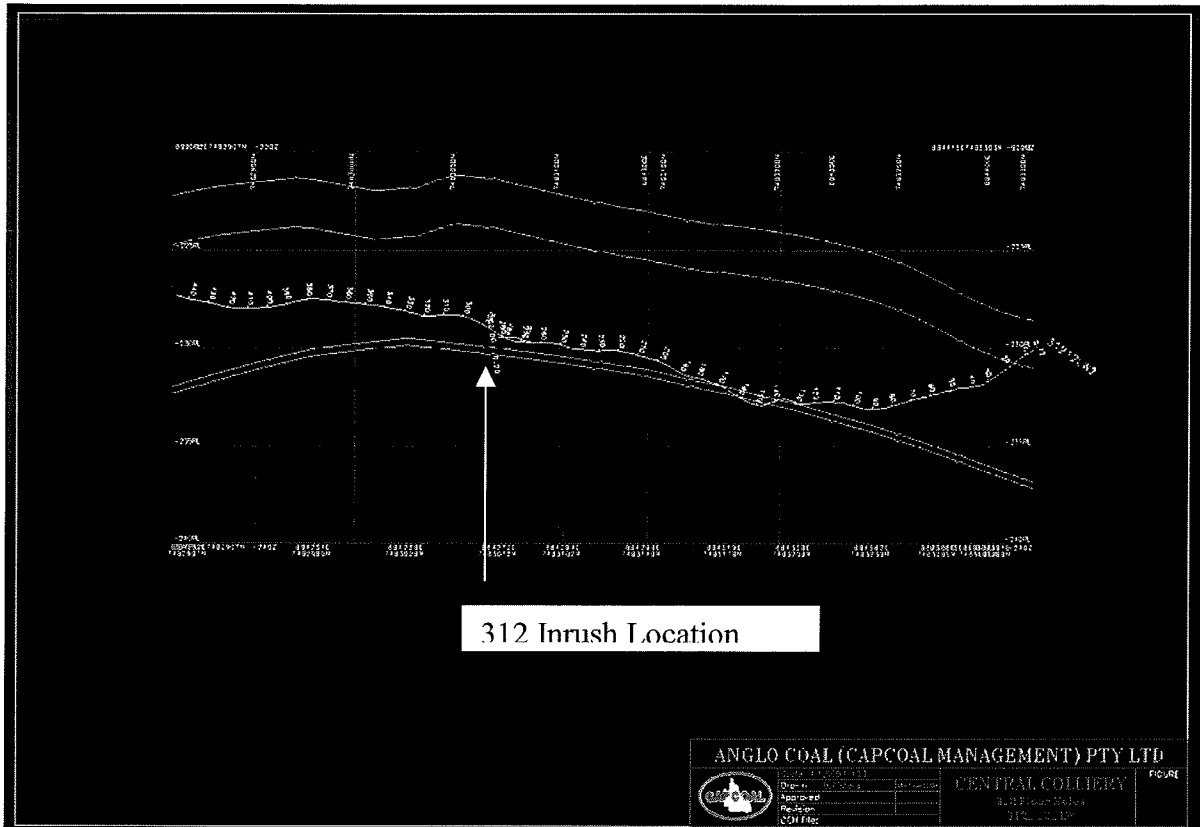
Figure 13: 312/12/LW Borehole Profile

In the above figure it can be seen that at the point where the inrush occurred, a floor touch had been made and the hole was branched. From this point, the hole was kept high but the German Creek Lower seam also begins to roll away as the cross grade steepens. The end result is that the interburden between the hole and the German Creek Lower increases to a point where the hole may not be effective. In conjunction with the lack of defects in the strata, gas potentially has not been able to bleed off with this hole. When the weighting event occurred, the strata cracked releasing gas into the workings. This is the most likely cause of the 312 event.

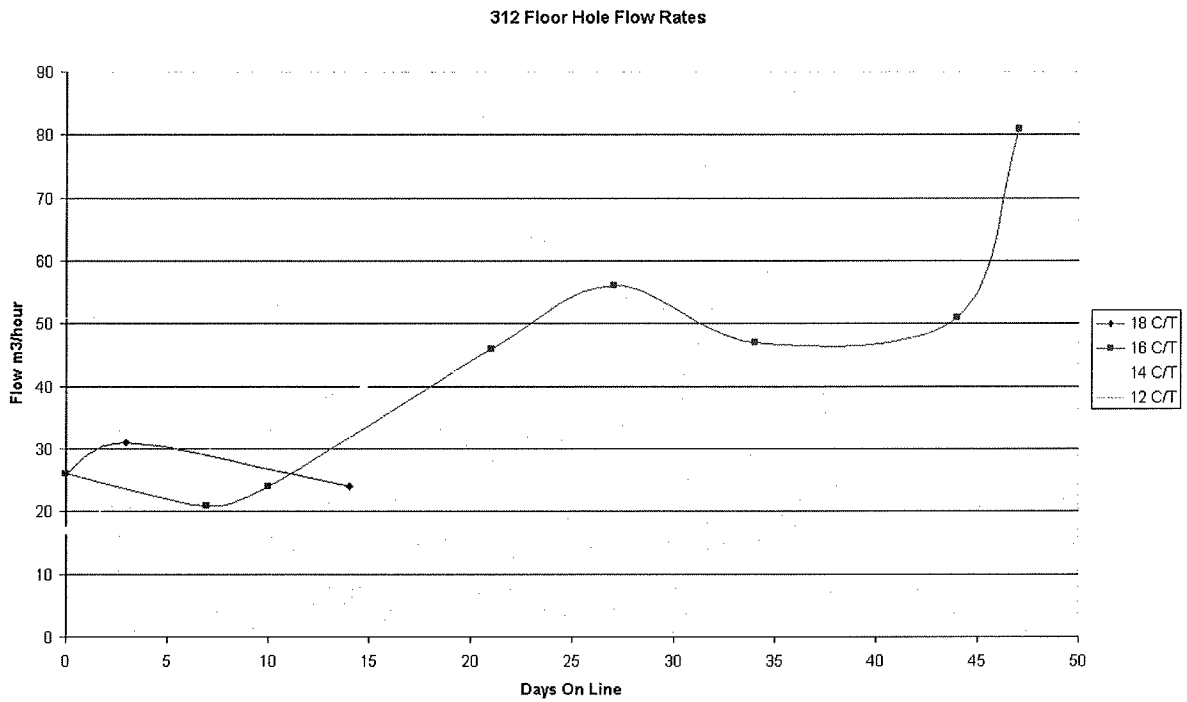
Figure 14: 312 Floor Hole Production Rates

After reviewing the graphs it is difficult to find a correlation between hole location and gas production. For example, hole 312/18/LW had low production and most of the hole was predominately in the top half of the interburden and hole 312/16/LW which was below the GCL (where you would expect no production) had high production. (gas may be entering at the hole / GCL interface). Hole 312/14/LW which has a similar profile to 312/12/10 which failed has average gas production. It is believed that the gas production data is not measured routinely enough to make a recommendation the ideal location for hole position. Also no gas production is an important measurement with metres extracted over the hole. It is therefore recommended that hole design remains targeted within 2 metres of the German Creek Lower Roof and any hole which is either drilled below the GCL seam or higher in the

interburden sequence by flagged on the hazard plan as a potential hazard. Flow measurement data should be collected more routinely in conjunction with hole profile and longwall position to determine if a design optimisation can be achieved.
