## CHAPTER 7

### SOME FINDINGS ON RE-ANALYSIS OF MOURA EXPLOSION

By  
A. Green, S. Leivesley

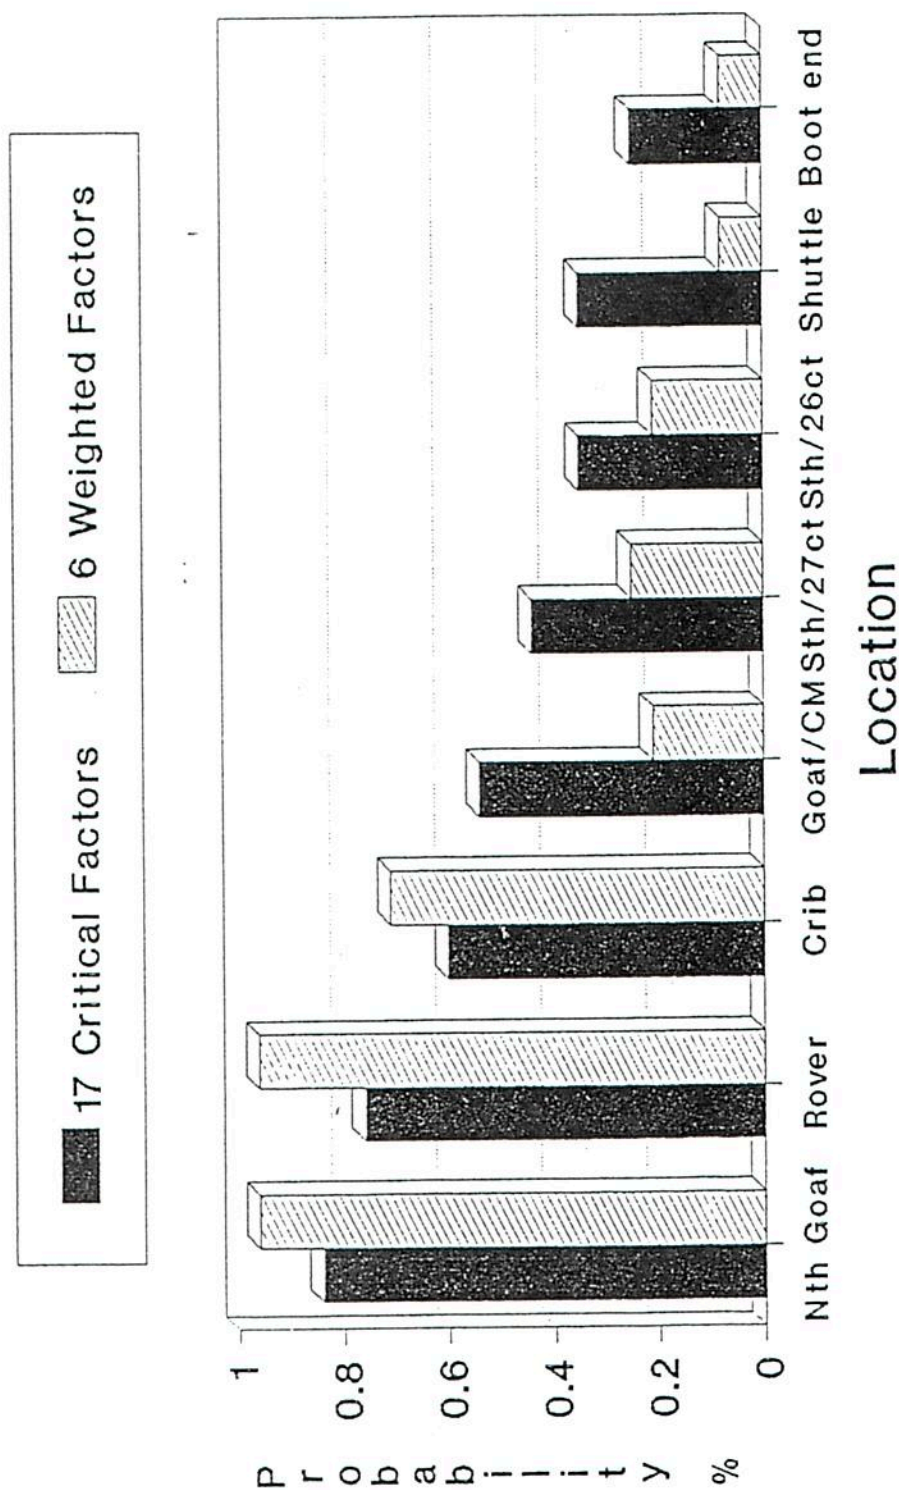
# Figure 7.1 Ignition Sources Probability for various locations

Figure 7.1 plots a percentage probability of ignition for several hypothesised ignition zones. The scaling has been based on +2 for a positive factor, +1 for a positive factor that needs further testing, 0 for a neutral or unknown factor, -1 for a negative factor that needs further testing and -2 for a negative factor. This process results in a value for each hypothesis between +34 and -34. This range has been converted to a percentage probability.

It is clearly seen that the regions above 50% probability lie in an arc from the goaf area to the west of the continuous miner around to the crib room area. The maximum value occurs in the north goaf in front of No.4 Supply Road.
