Mackay Office

| Mine Name | Mine ID | Operator | Activity Type | Activity Date |
|---|---|---|---|---|
| Goonyella Riverside | MI00568 | BM Alliance Coal | Inspection | 03/04/2019 |

Mine Record Entry

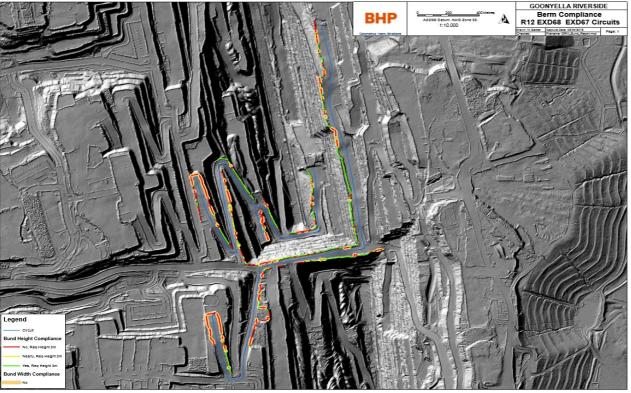
- Excavator 68 was digging overburden in Ramp 12 and the trucks were hauling this material to an out of pit dump. There were sections of road edge safety berms on this circuit protecting significant roadside drop-offs that didn't appear to meet the design requirements for high risk berms. We later requested for a survey pick-up of this area to check the actual safety berm dimensions against the SHMS' design requirements. This survey pick-up verified our observation by showing sections of safety berms did not meet the design requirements (refer to **Figure 1** on page 3).

• Excavator 67 was also digging overburden in Ramp 12 and the trucks were dumping this material in pit on the low wall side. Again there were sections of road edge safety berms on this circuit protecting significant roadside drop-offs that didn't appear to meet the design requirements for high risk berms. We also requested that a survey pick-up of this area to check the actual safety berm dimensions against the SHMS' design requirements. This survey pick-up verified our observation by showing sections of safety berms did not meet the design requirements (refer to Figure 1 below).

Figure 1. Survey pick-up of Excavator 67 & 68 circuits showing safety berm non-compliance to design requirements

Audit all roadside safety berms for compliance to the SHMS' design requirements where there is a drop off greater than .5mt. The results of this audit are to be provided to myself, and where areas of non-compliance are identified a corrective plan to fix the non-compliance is to also be provided.
