CENTRAL COLLIERY

**312 GERMAN CREEK LOWER
CH₄ "FLOOR BLOWER" REVIEW**

Darren Pisters
Chief Geologist
September 2004

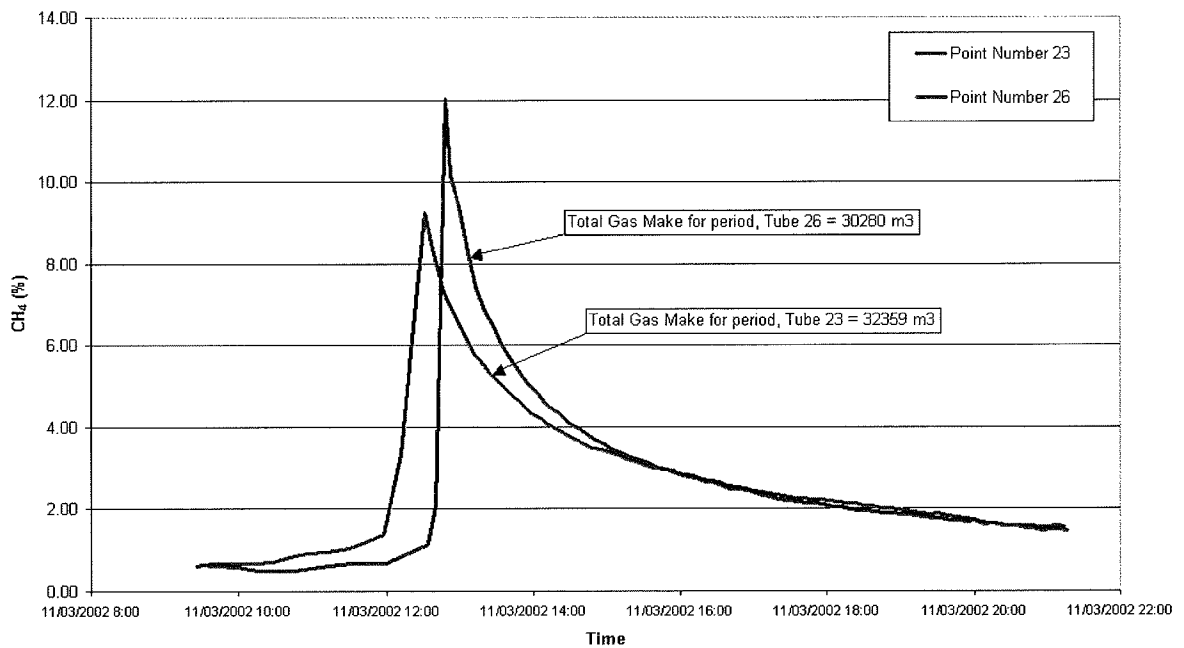
Figure 6: 310 TG Gas Make – 11/3/02

The gas incident at 310 LW on the 11th March 2002 can be seen from Figure 4 to be largely related to a floor hole not being drilled at this location. The second incident on the 6th June 2002 was related to the floor hole being turned off at the collar. Therefore the incident on 27th August 2004 at 312 can be considered the first “true” failure of the floor drainage system and therefore requires to be evaluated in detail. The next series of sections further evaluates this failure.

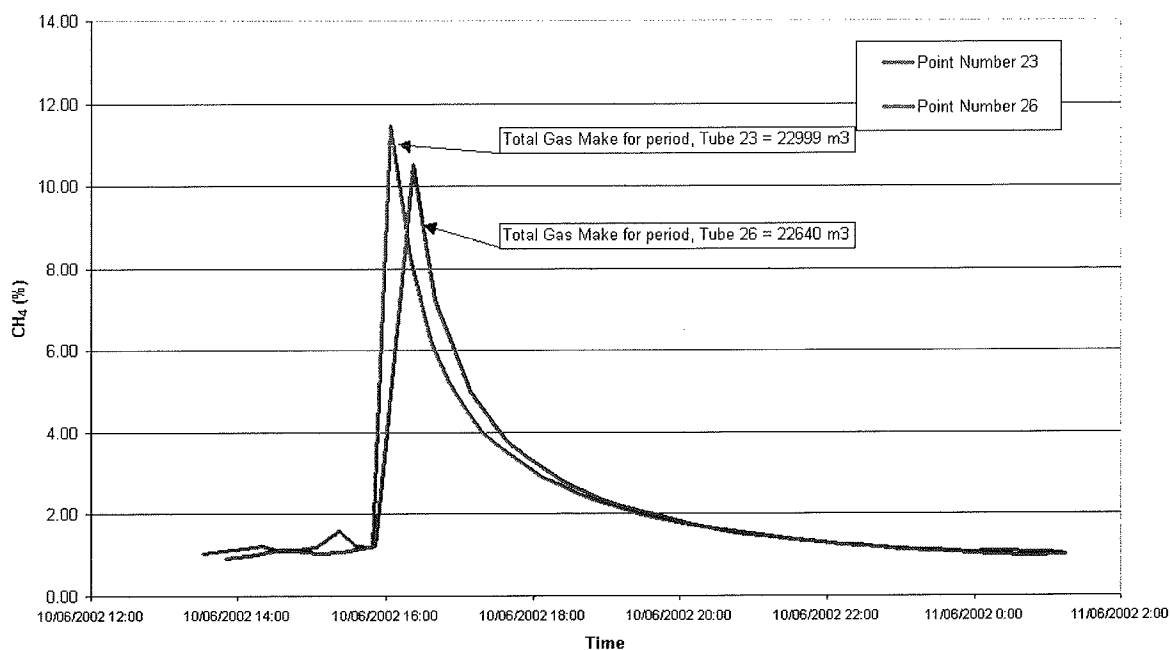
Figure 7: 310 TG Gas Make 10/6/04

The event in 310 LW on 10 June 2002 was in a location where a floor hole had been turned off at the collar. This event can therefore not be regarded as a failure of the system. Gas make was reported to be in the mid face region which is the most likely location for cracking to occur. Figure 11 shows also that the mid face region is an area of intersecting joint sets from both the maingate and the tailgate. In this case however, it is not clear whether structure plays any role with the location of the floor blower.

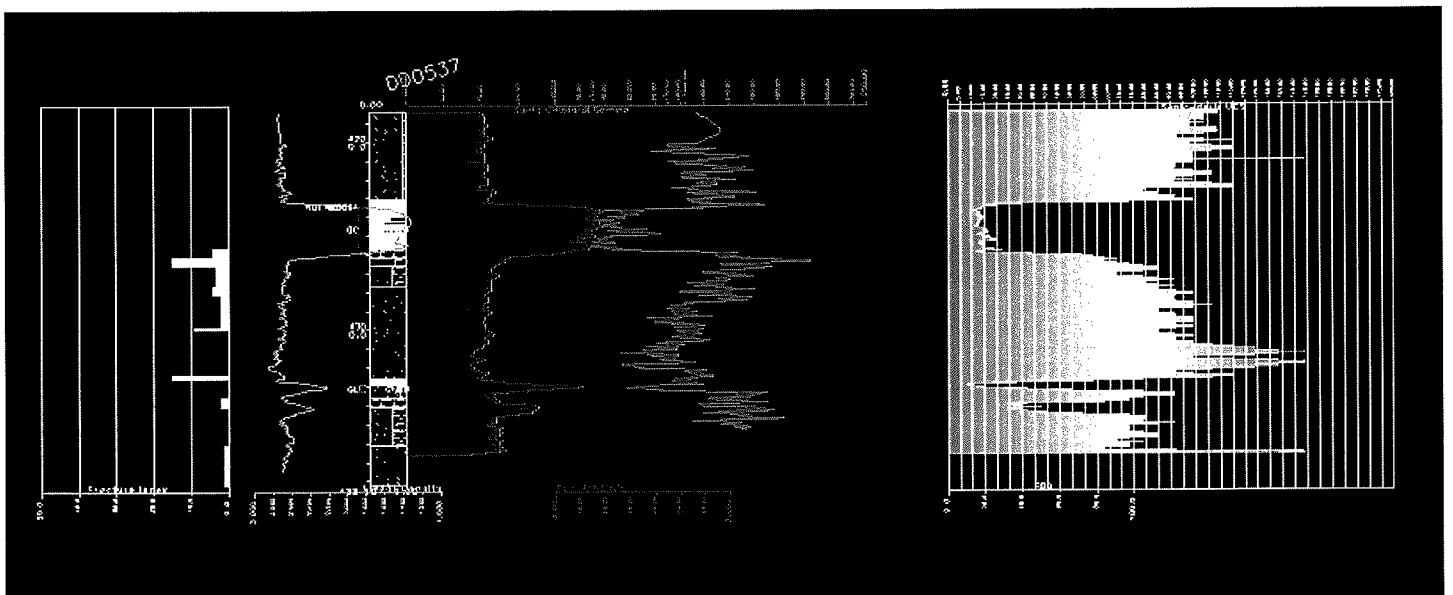
Figure 8 – Lithological and geophysical profile of DD0537

- Floor Unit 1 - Laminated siltstone and carbonaceous mudstone, weak to moderate in strength (UCS 20 –50 MPa)
- Floor Unit 2 - Medium grained sandstone, strong to very strong (UCS 60 –70 MPa) with occasional weak bedding planes. (not present at CC but grades in at GT and SC)
- Floor Unit 3 - Laminated fine grained sandstone and siltstone, moderate – strong rock with numerous weak bedding planes.
- Floor Unit 4 - Medium grained sandstone, strong to very strong rock (UCS 80 –90 MPa) with occasional weak bedding planes.

These units can be seen on the following borehole profile and core photographs of borehole DD0537 located mid block of 18 c/t 312LW panel.

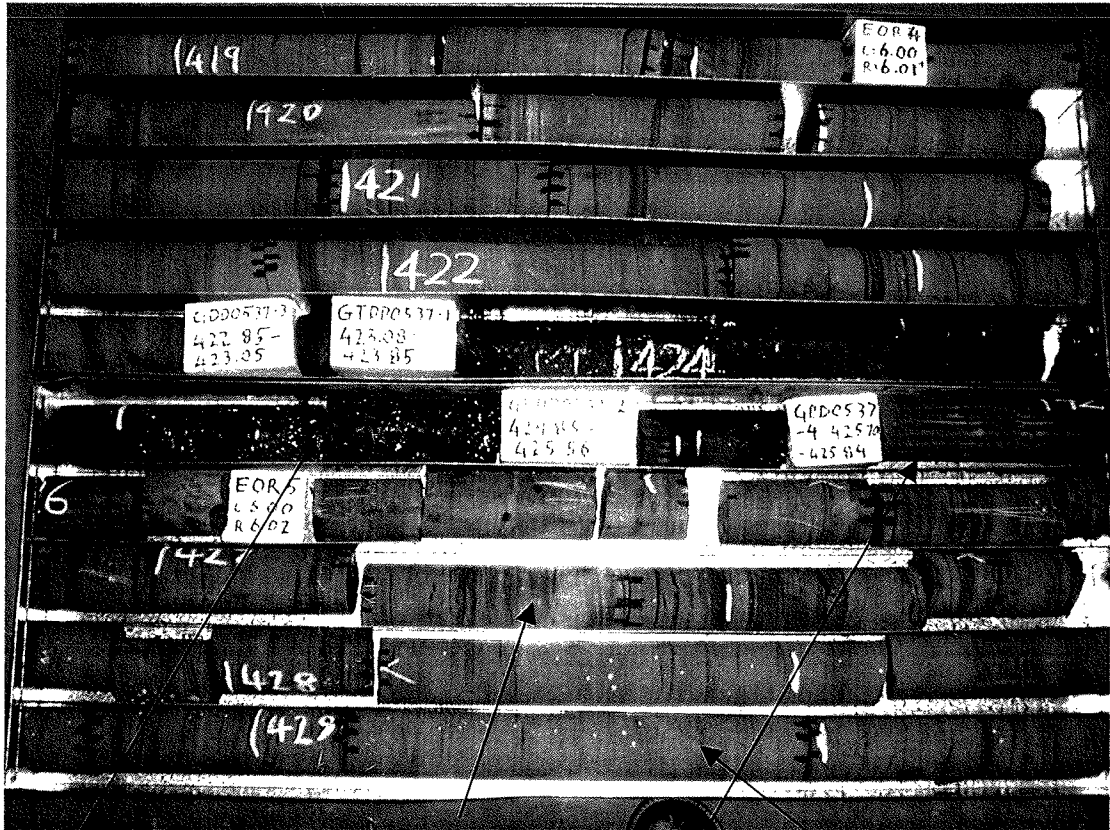
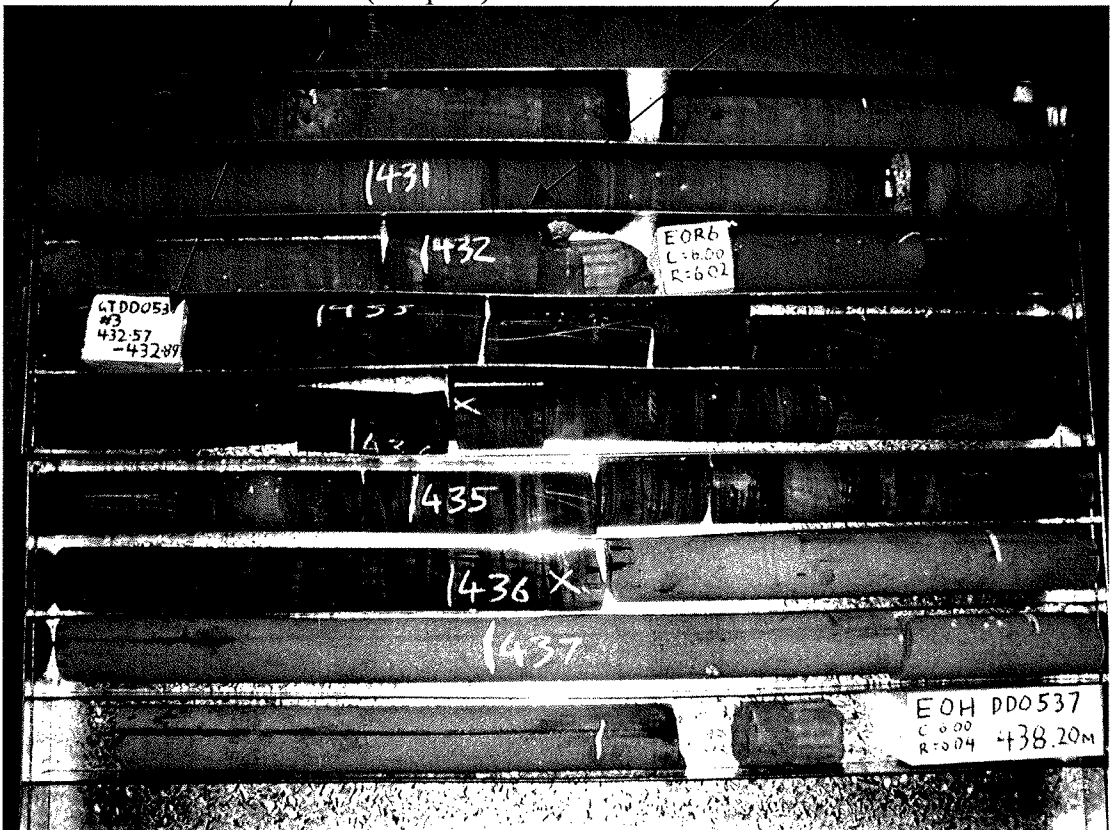
Plates 1 and 2 – Core Photographs DD0537

German Creek Seam Floor Unit 3 Floor Unit 1 Floor unit 4
 German Creek Lower seam (sampled)
