Where are we now?

Some 11 years after

Moura No. 2 Disaster

John P. Brady October 2005

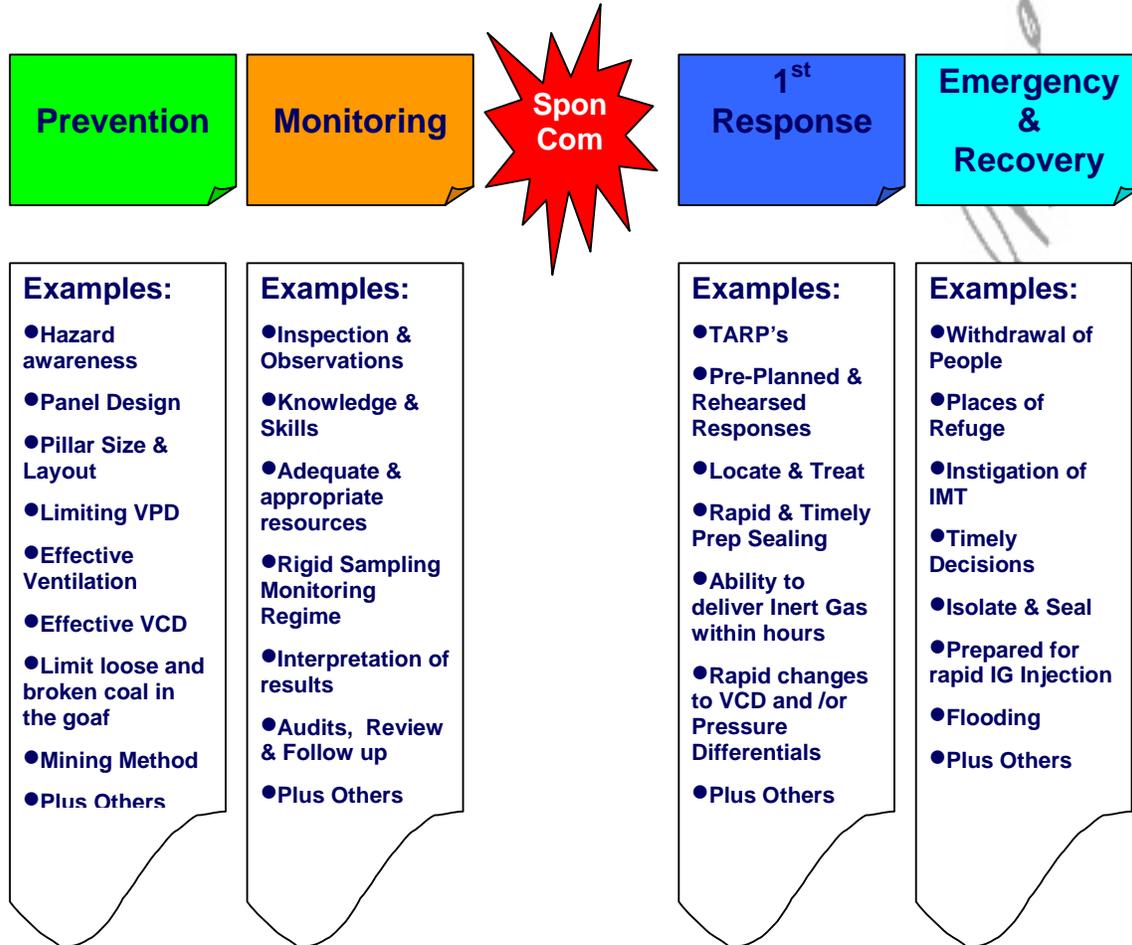
4.3 Hazard Specific Barriers for Spontaneous Combustion

We can gain a better understanding of the challenges associated with spontaneous combustion by applying the MIRM Model and in particular the elements of the Work Process Factors that deal with Hazard specific Barriers; for example:
